UH Children’s Learning Centers
SFAC FY2024 One Time Request

FY2024 One Time Funding Request	
CLC Wheeler Exterior Building Repairs and Paint <ul style="list-style-type: none"> • Doors & Building Painting (\$114,674.40) • Reseal all Windows in 9 Classrooms (\$14,067.50) • Metal Siding Repair (\$25,226.76) • Labor and Consultation fees (\$70,492.00) 	\$206,700
6% Administration Fee <ul style="list-style-type: none"> • CLC Wheeler Repairs 	\$12,402
Total-	\$219,102

CLC Wheeler Facility Condition Assessment (Child Care Center Building 504)

Inspected May 30, 2019

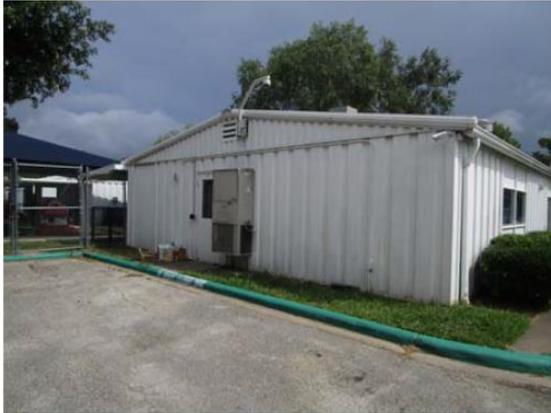
504081a 5/30/2019

North facade exterior
Administrative building

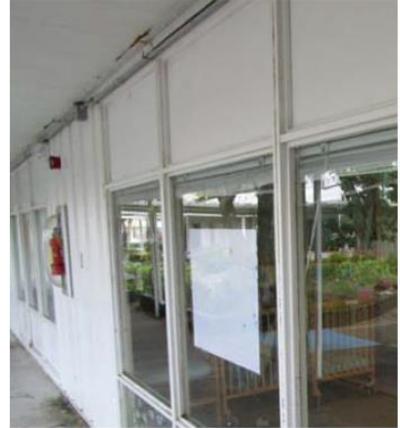
504005a 5/30/2019

Original single-pane glazing on north exterior
Classroom building 111/112/113

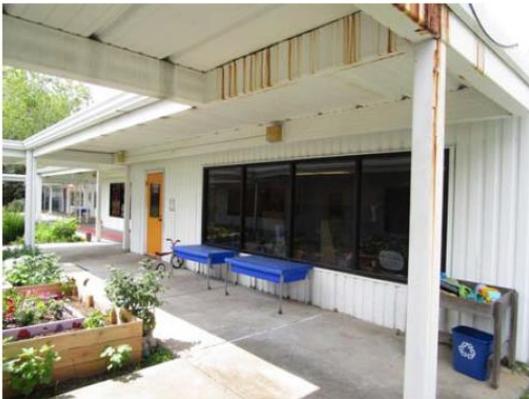
504032a 5/30/2019

South facade exterior
Classroom building 117/118

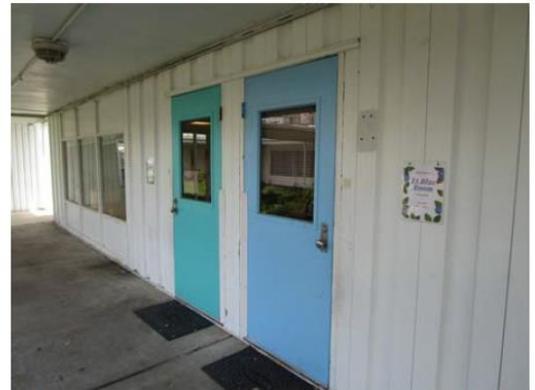
504008a 5/30/2019

Painted hollow metal exterior pedestrian door with glass,
commercial knob lockset, and noncompliant signage
Classroom building 111/112/113

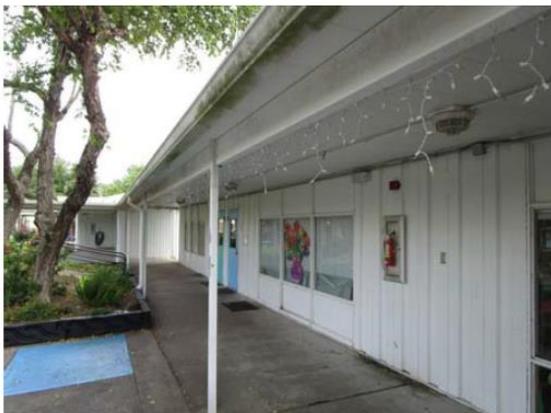
504006a 5/30/2019

North facade exterior
Classroom building 111/112/113

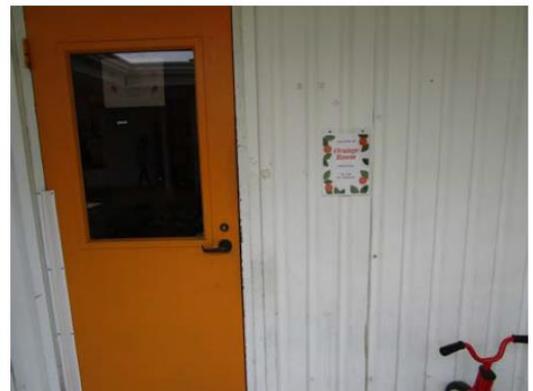
504033a 5/30/2019

Painted hollow metal exterior pedestrian door with glass,
commercial lever lockset, and noncompliant signage
Classroom building 117/118

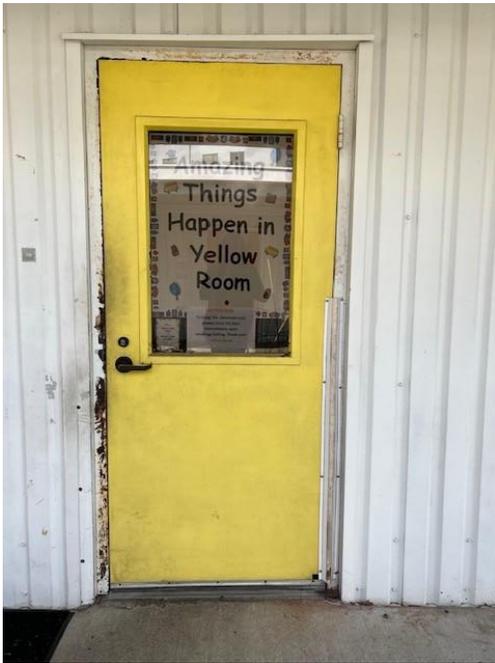
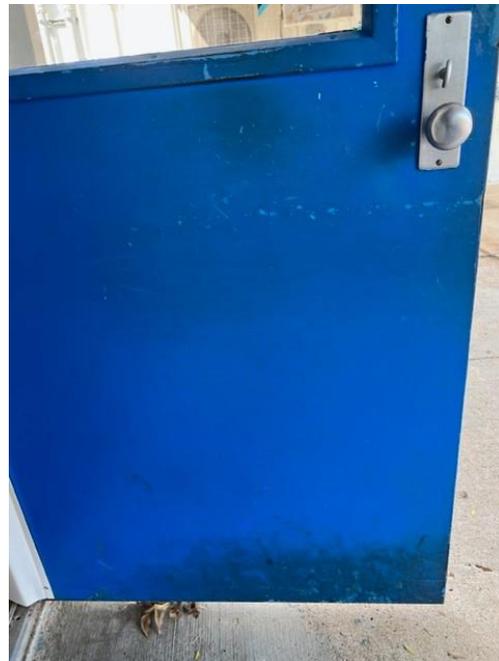
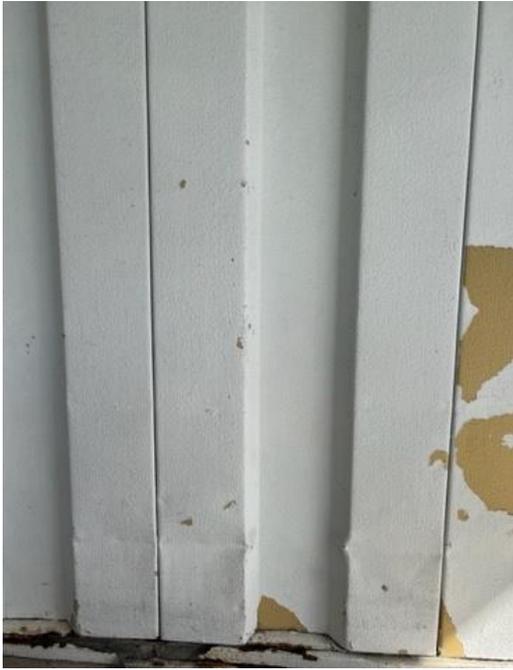
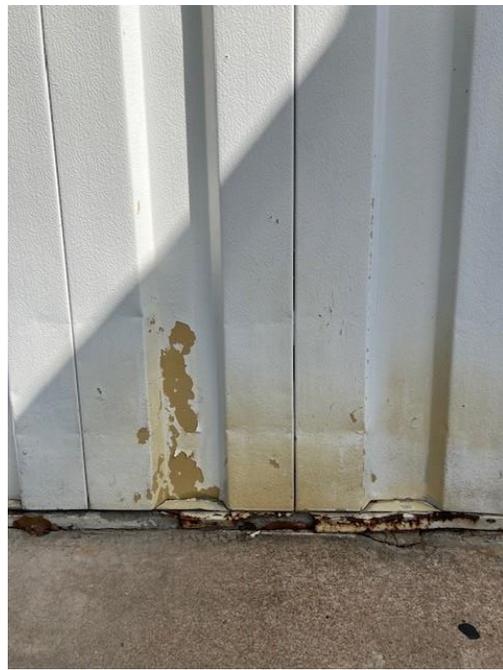
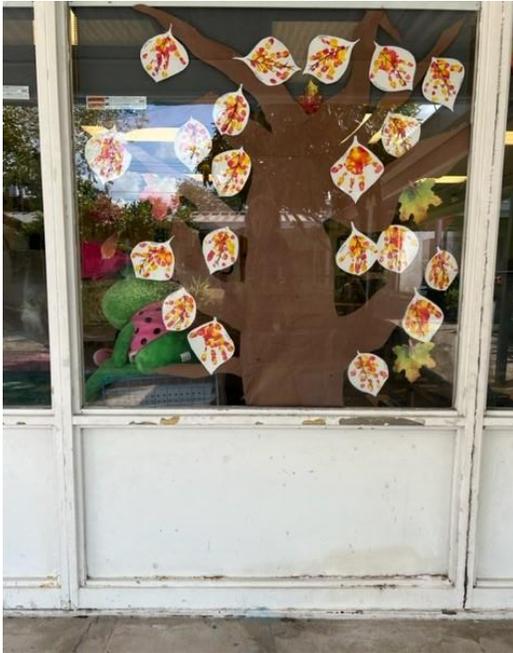
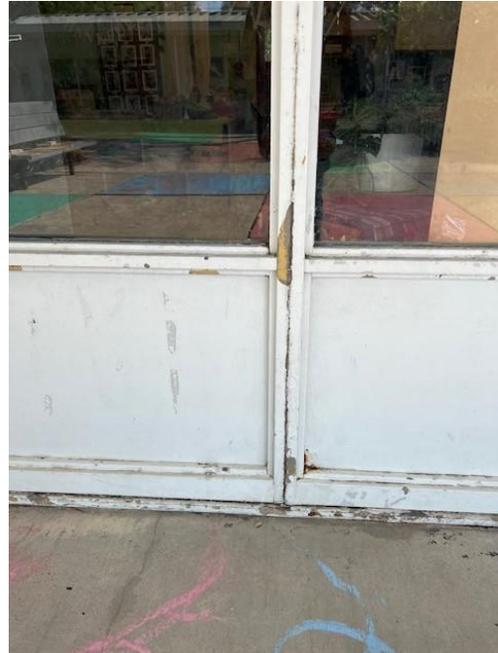
Some pictures of the affected areas, taken October 2023, are shown below.
